# Jack Mears Spring Rehabilitation Landscape Management Plan

Shire of Collie

10 March 2017

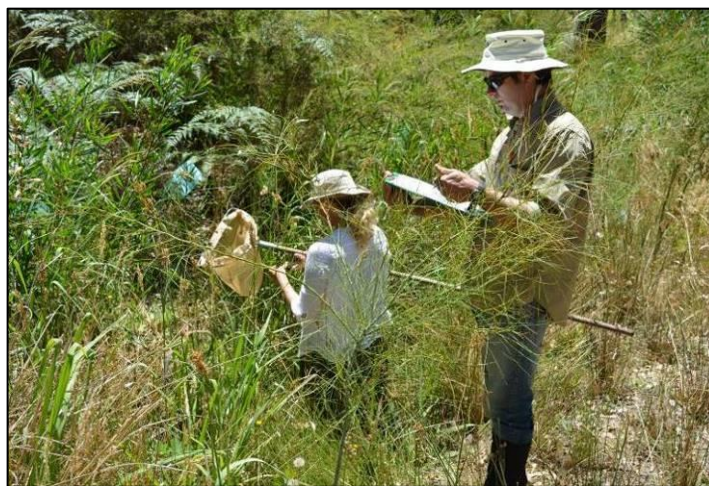
**Plate 1: Macro-invertebrate sampling of the Spring fed Stream**

The length of stream sampled at each site varied between three and five metres. This was due to dense vegetation growth limiting accessibility to the stream. Sampling included all habitats present at each site, including agitation of aquatic vegetation, kick sampling of stream bed, and sweeping in open channels. Live-picking of aquatic invertebrates was completed on-site for each sample to obtain specimens for each taxa present.

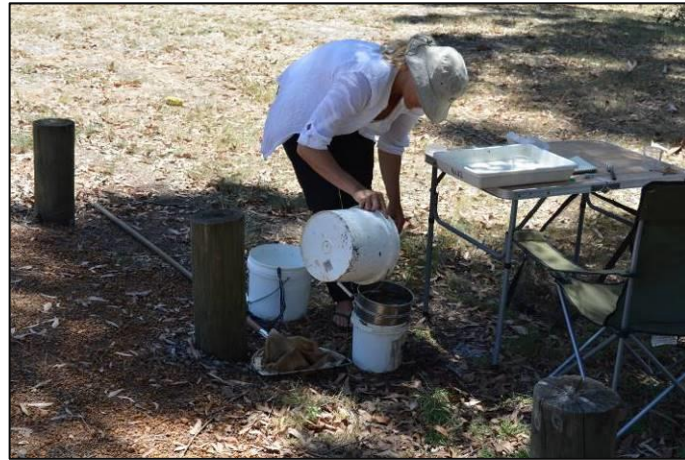
**Plate 2: Live Picking of Aquatic Invertebrates**

The aquatic invertebrate survey of the spring channel was undertaken by Aquatic Ecologist Dr Robyn Paice to determine the presence of a shrimp species that had been previously sighted by a community member. Two-minute sweep-net sampling was undertaken at three sample sites along the small spring-fed stream. Each sample site is described in Table 1, and their locations can be seen on Figure 2.

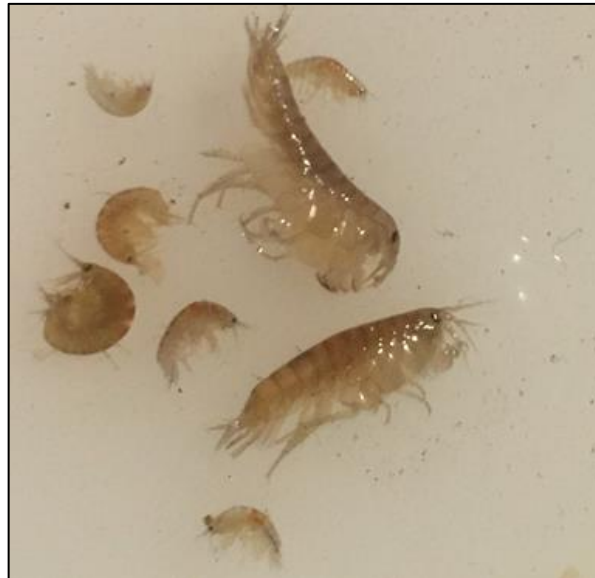
**Plate 3: The Amphipod *Perthia acutitelson***

*Perthia acutitelson* was found at relatively high abundance. This species was most abundant in the headwater at site A. This species, an Amphipod is often referred to as shrimp, and may be the organism responsible for anecdotal shrimp sightings by community members.

*Perithia acutitelson* an Amphipod, was found in relatively high abundance at the spring headwater, sample site A (refer to Figure 2). The species was quite conspicuous at the headwaters which is the most accessible part of the spring fed stream. The amphipod is up to 15mm in length and was easily observed by shifting small rocks or wood pieces.

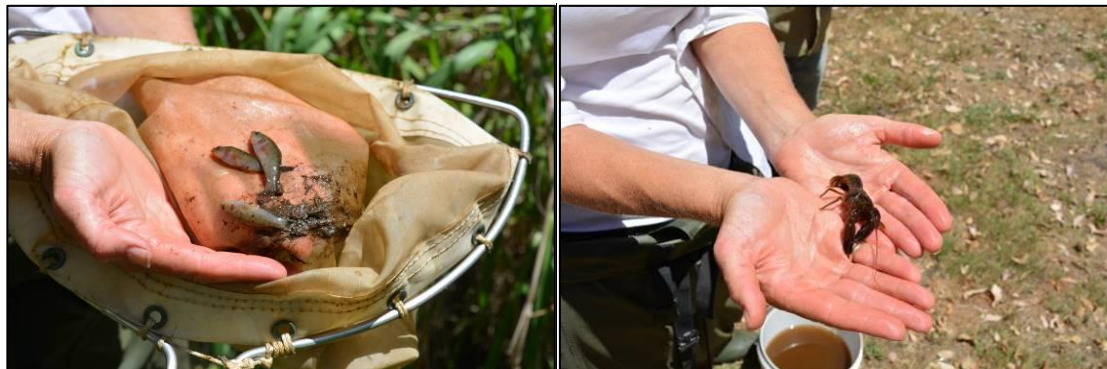
**Plate 4: Western pygmy perch and Gilgie recovered from Sample Site B**

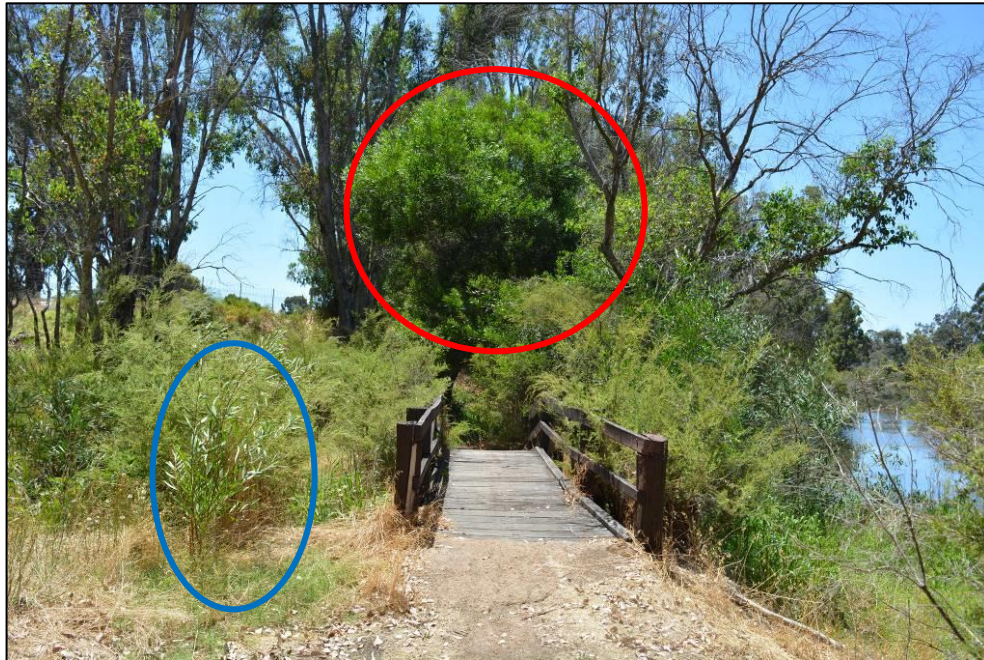
Plate 6: *Acacia longifolia* (Sydney Golden Wattle) Parent Tree (red) and Germinants (blue)

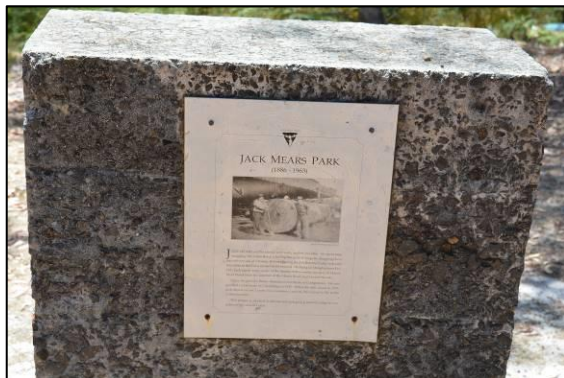
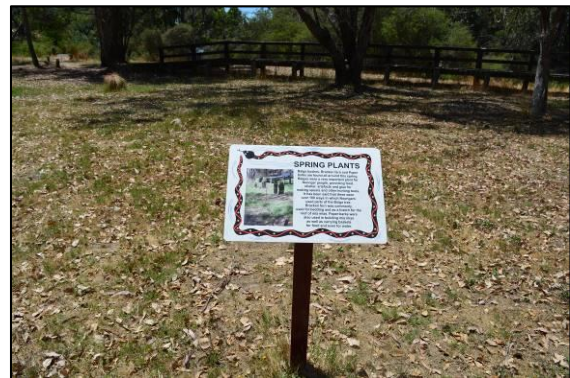
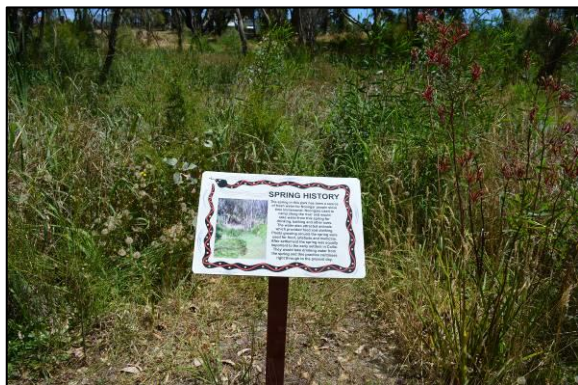
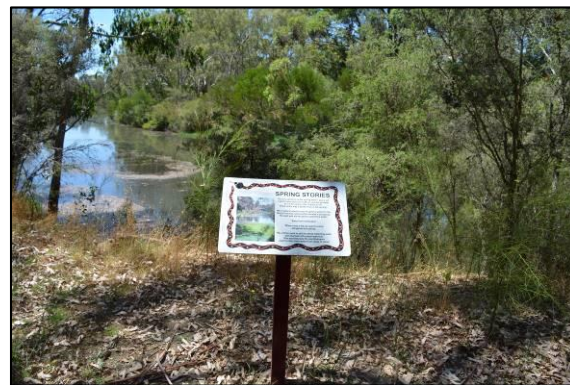
Plate 7: The Proposed Walking Path Would Lead Pedestrians Past these Interpretive Signs

Action	Description	Priority
Install an interpretive walking path	Construct a walking path from the road verge that guides pedestrians across the headwaters of the spring and the Jack Mears plaque and leads people past the three Aboriginal cultural interpretive signs and back to the board walk along the Collie River.  SWCC recommend this path is formalised by curbing to prevent grass encroachment over the path and to encourage pedestrian not to stray into vegetated areas.  Site monitor/s will be required onsite should excavation be required for this activity.	High
Removal of the <i>Acacia longifolia</i> parent trees	Several mature <i>A longifolia</i> trees occur on the outskirts of the project area. These trees are the seed source for the germinants that occur throughout the damp zone and along the stream channel. Removal of these trees will limit ongoing germination (see Plate 6).	High
Tree guard removal	The project area is littered with tree guards from past revegetation efforts. The guards look unsightly, may encourage other littering and may eventually enter the Collie River.	High

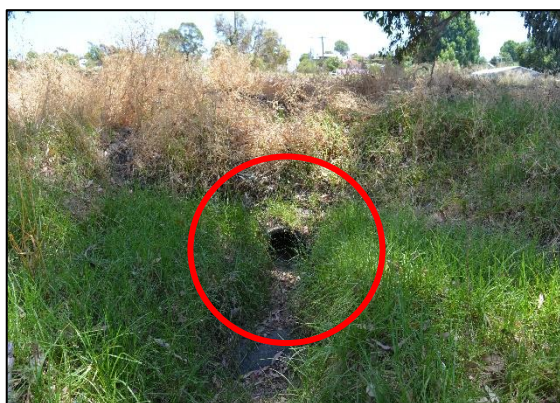
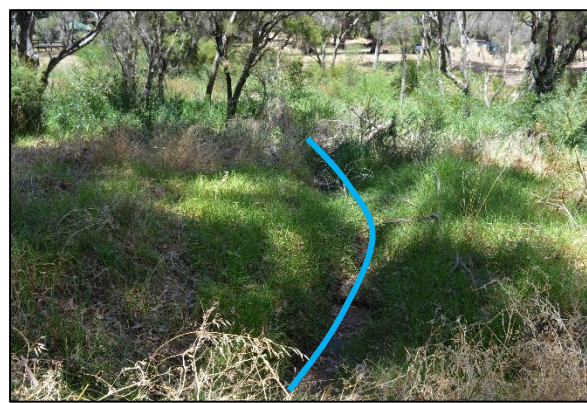
- A lack of microhabitat to support and shelter native fauna.
  - Minor gully erosion from a stormwater drain that discharges downstream of the spring headwaters.

Action	Description	Priority
	aquatic invertebrates and other fauna that are known to occur within the stream.	
Stormwater Drain and Gully Erosion	<p>Figure 2 and Plate 8 shows the location of a stormwater drain that discharges downstream of the spring headwaters. It is assumed that this is run off from the road catchment. A small gully has eroded below the discharge point that may require stabilisation works in the future.</p> <p>SWCC suggest the Shire investigate the possibility of relocating the storm water flow to another discharge location. There is a risk that pollution from this point source may negatively impact the reserve area and the water quality of the stream.</p> <p>The Shire should consider Water Sensitive Urban Design principles to filter stormwater prior to discharge into the environment.</p>	Med

**Plate 8: Stormwater discharge point and minor gully erosion**

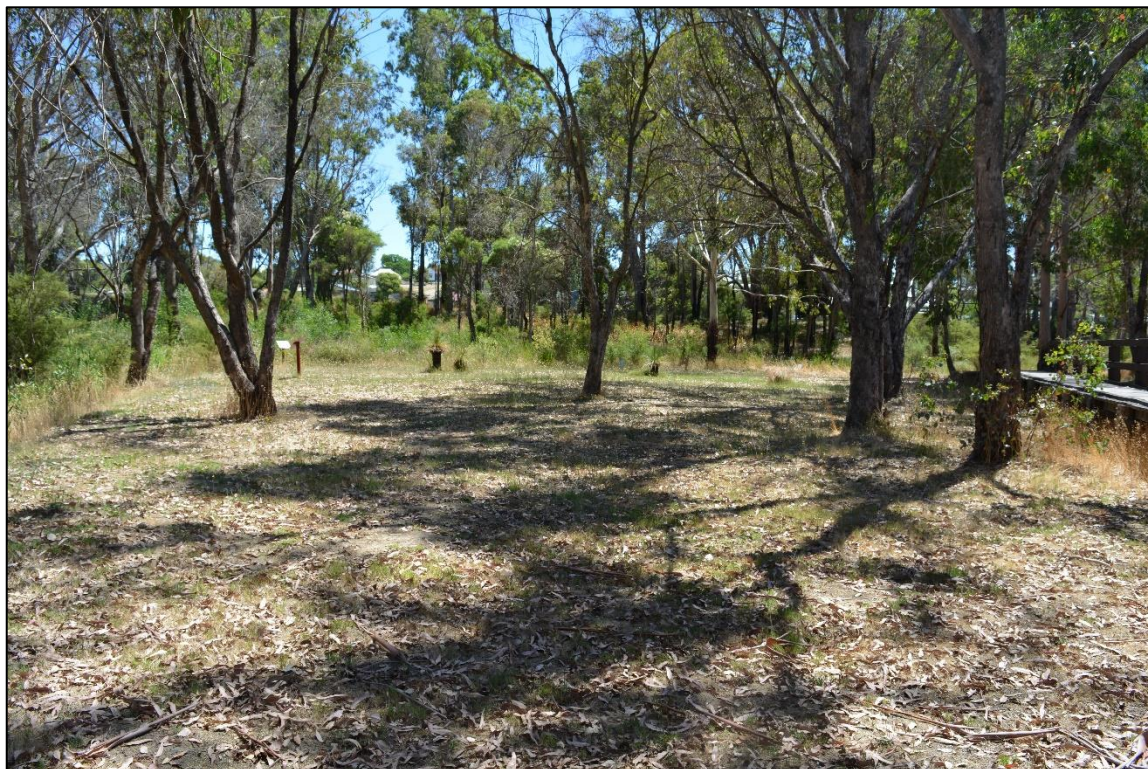
- Poor to nil presence of understorey species.
- Diversion Drain Zone:
  - Minor gully erosion from surface runoff from the adjacent open space and driveway.

Table 11 details the recommended actions specific to the reserve flat. Plate 9 illustrates the lack of understorey species present within this zone.

**Plate 9: Reserve Flat Zone void of Understorey Species**

Action	Description	Priority
Understorey establishment	<p>The proposed walk path winds through this area leading people past the Aboriginal interpretive signs.</p> <p>SWCC propose the remaining area is mulched and planted out with a selection of native understorey species (1 plant per 2-3 m<sup>2</sup>). Understorey species should be chosen to not impede the view from the boardwalk across to the Spring (&lt;1.5m tall).</p> <p>Mulching will provide ongoing weed control and maintain soil moisture.</p>	High
Weed control	Required to remove grass and flat weed competition prior to the proposed planting and mulching.	High
Blue gum removal	Blue gum removal to prevent spread via seed.	Low

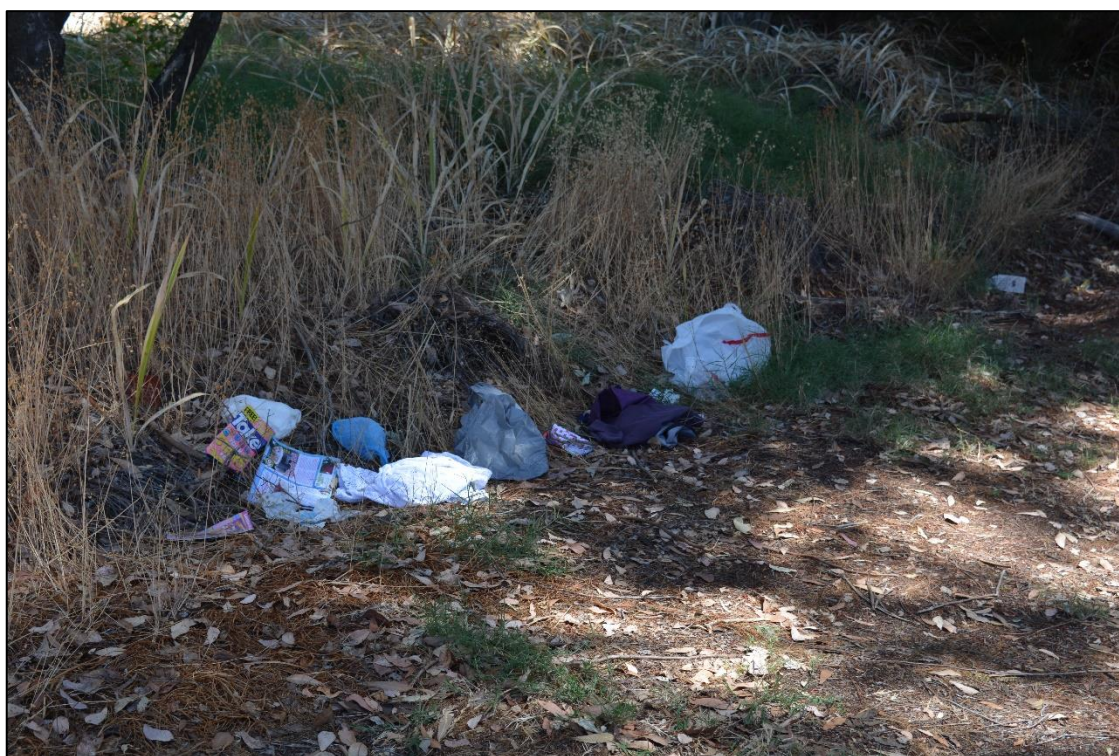
**Plate 10: Rubbish dumped within the Public Open Space Zone**

Action	Description	Priority
Install a public bin	Litter was prevalent in this area (see Plate 10). A bin station is present adjacent to the car park but there was no bin present at the time of the site assessment.	Med
Maintain turf area	As a public open space a mowed and maintained area may encourage people to picnic and use the area more regularly.	Med
Blue gum removal	Numerous blue gum trees occur within this area. Blue gums are not native to Western Australia and can displace native species. They shed their bark in long strips and can appear unsightly.	Low
