Phytophthora Dieback Assessment Report

Minninup Pool Project Development Investigation Area (DIA)

A report prepared for the: Shire of Collie, Western Australia

December 2021

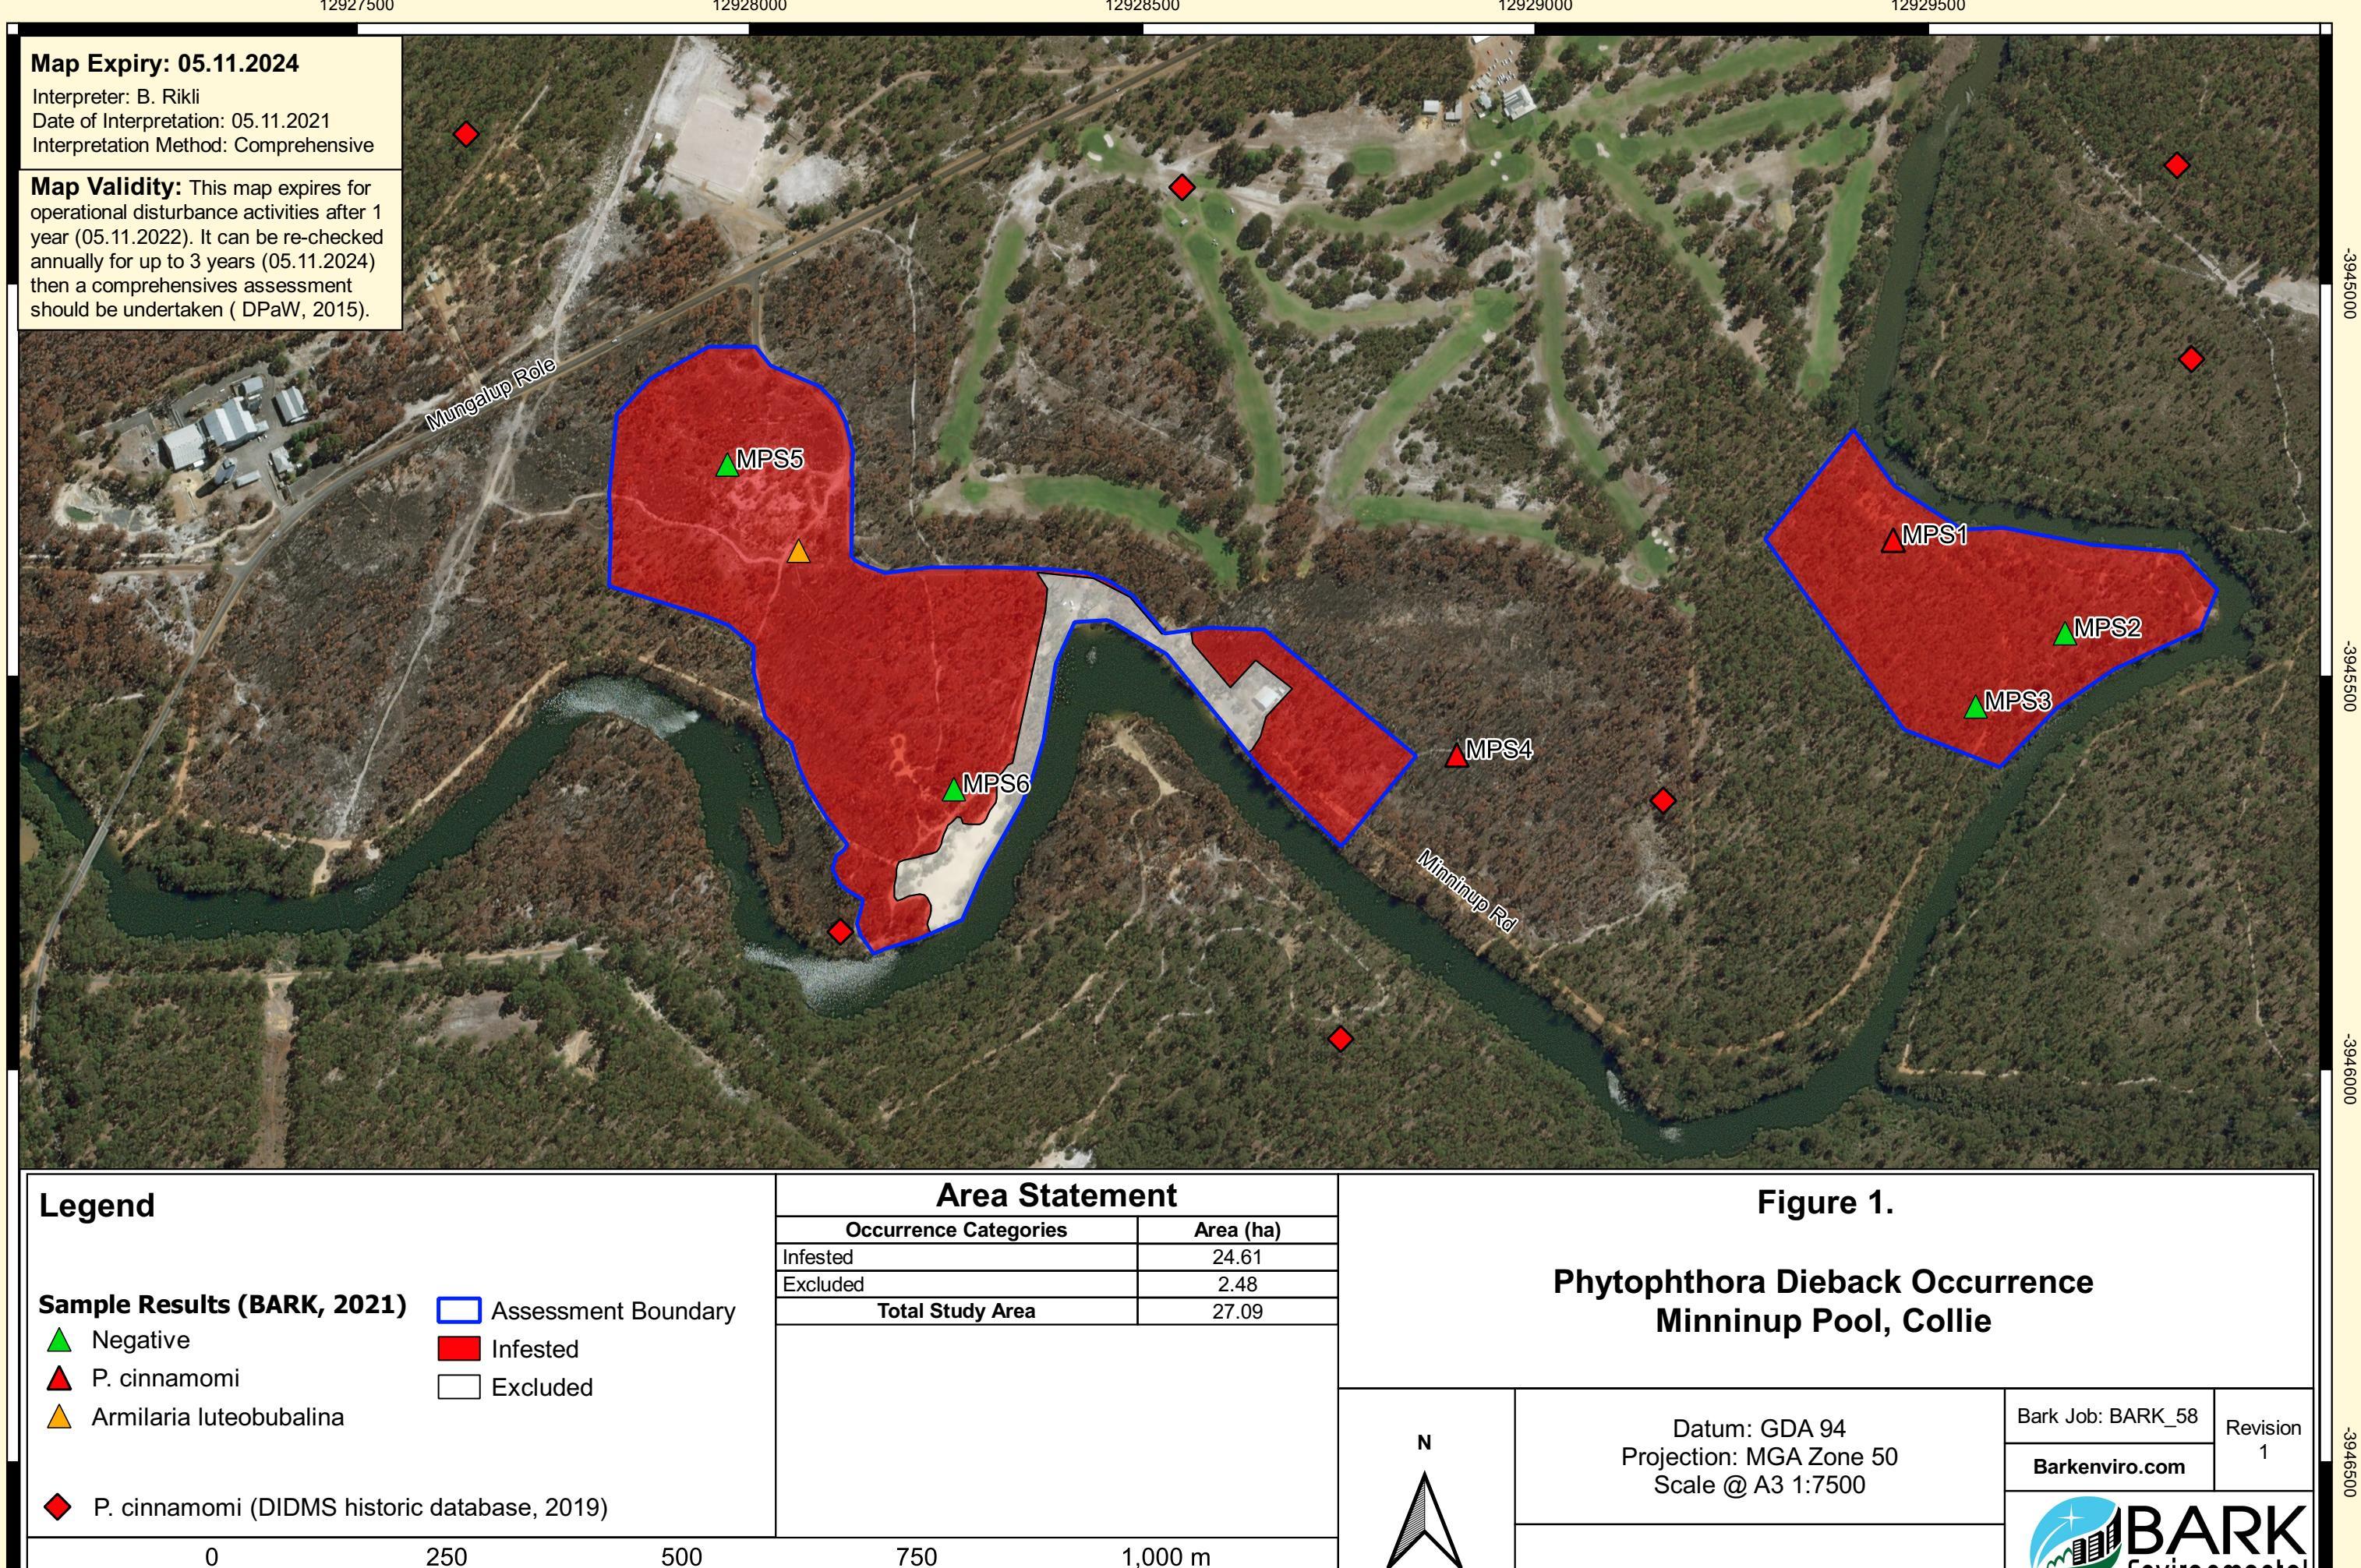
Two Dieback occurrence categories have been determined over the subject area (Table 2). Figure 1 shows the spatial distribution of these two Dieback mapping categories (see attached).

A Dieback Occurrence Map has been prepared that shows disease occurrence boundaries and current/historic sample points (See Figure 1).
